HISTORIC RESOURCES ASSESSMENT

**CITRUS SQUARE PROJECT
CITY OF CYPRESS
ORANGE COUNTY, CALIFORNIA**

June 2021

LSA Project No. CCP1603.11

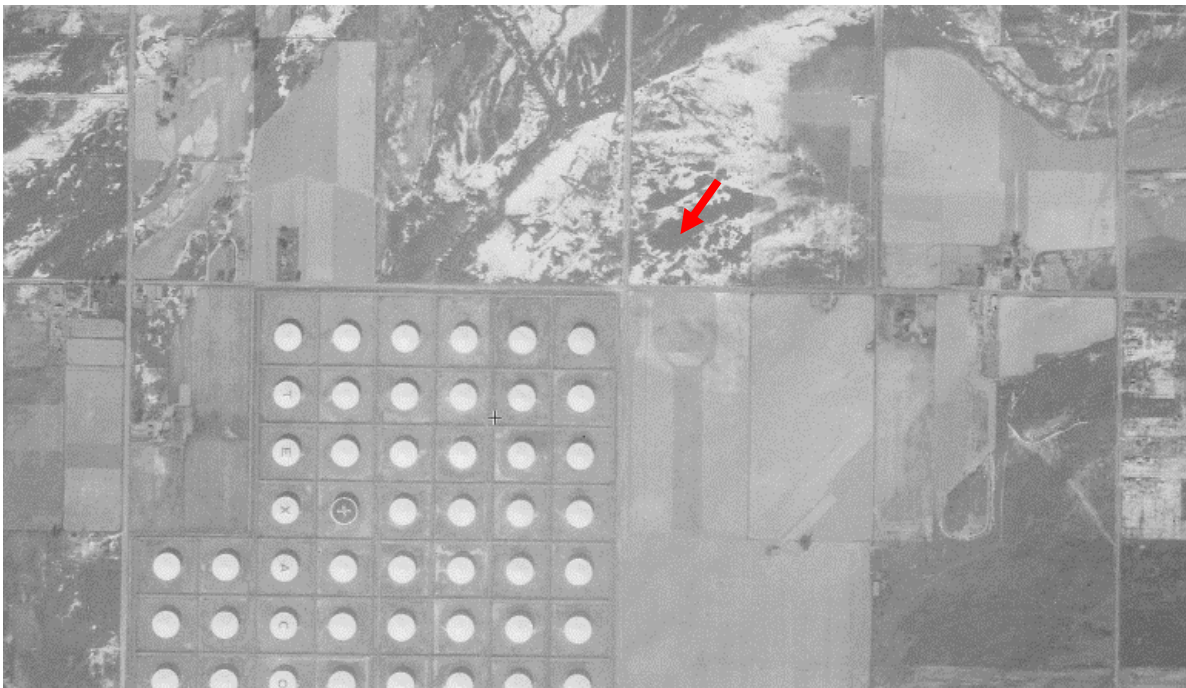
Figure 3: 1930 Historic Aerial photograph showing general area of subject property. The white circles are the Texaco tank farm located at the southwest corner of Moody Street and Orange Avenue. The red arrow points to the general project location (UCSB Aerial Photographs 2021).

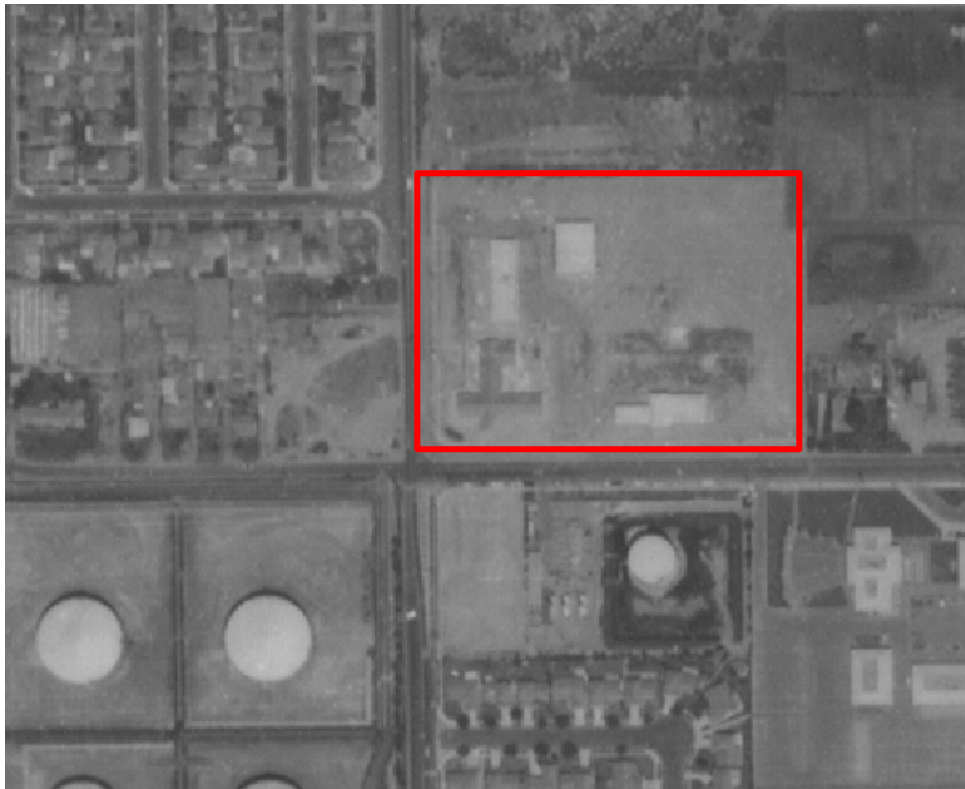
Figure 4: 1968 historic aerial photograph showing the Cypress School District administrative and support facilities outlined in red.

Major east/west street is Orange Avenue and north/south street is Moody Street (UCSB Aerial Photographs 2021).

The Cypress School District opened its new administrative offices in 1968 (Figure 4). The new campus consisted of the Administration Building, Educational Center, Warehouse, and Vehicle Maintenance Shop (City of Cypress n.d.:9; UCSB 2021). A Maintenance Shop and Equipment Storage Shed were added by 1976 (UCSB 2021). Since then, several buildings have been added and removed from the site. Currently, the Cypress School District serves six elementary schools, 3,948 students, and 150 teachers (Public School Review 2021).

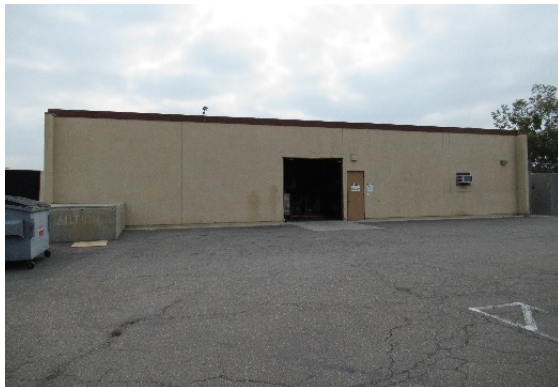
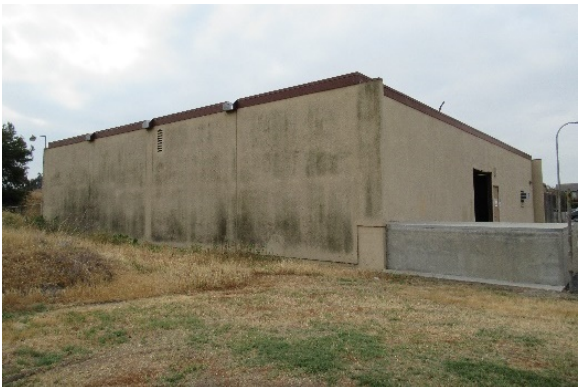
Located directly east of the Educational Center is the Warehouse (Figures 11 and 12). It has a rectangular floorplan, flat roof with low parapet wall and evenly spaced squared downspouts along the roofline. The building is clad with smooth stucco. A rollup car door is at the west elevation and a single metal door is immediately to its south. A secondary entrance is located on the south elevation. The Warehouse is in good condition and retains a good degree of integrity.

Figure 11: Warehouse, west elevation, view east (LSA 2021)

Figure 12: Warehouse, north elevation (left) and west elevation (right), view southeast (LSA 2021)

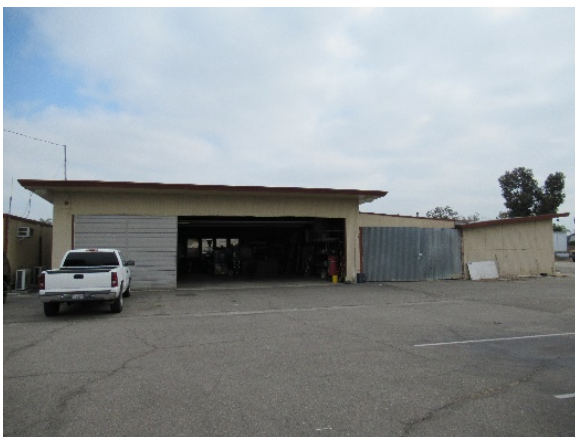
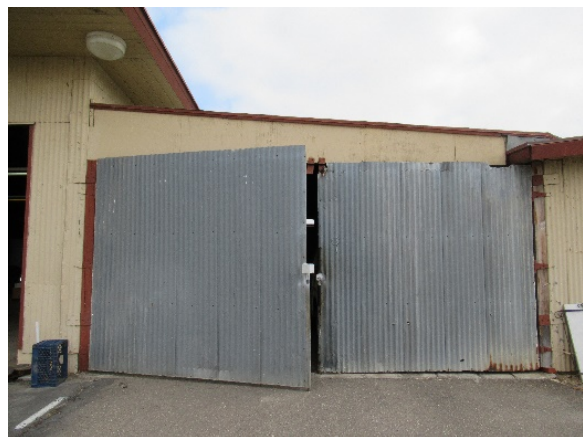
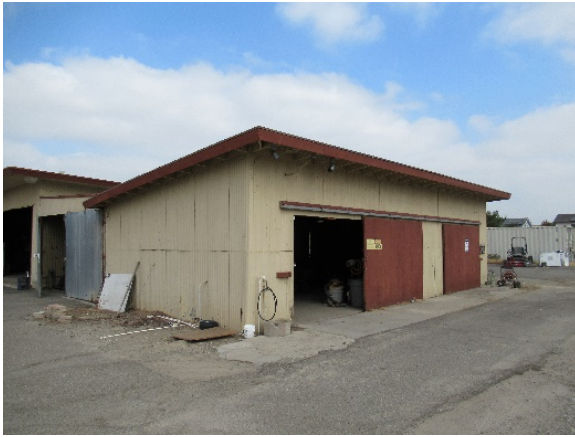
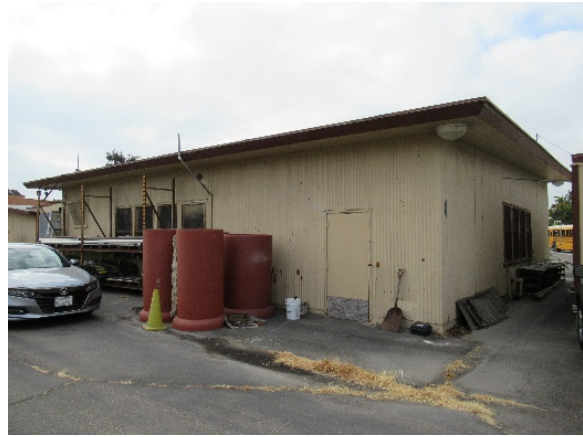
The Equipment Storage Shed, located east of the Maintenance Shop, has a rectangular floorplan, a flat roof that slopes to the west, and open eaves. It is clad with painted corrugated metal sheets. Two car openings, which consist of two wood, barn doors, are located on the east elevation. The Maintenance Shop and Equipment Storage Shed are in fair condition and retain a good degree of integrity.

Figure 17: Maintenance Shop and Equipment Storage Shed, south elevation, view north (LSA 2021)

Figure 18: Maintenance Shop and Equipment Storage Shed, south elevation, view north (LSA 2021)

Figure 19: Maintenance Shop and Equipment Storage Shed, south elevation (left) and east elevation (right), view northwest (LSA 2021)

Figure 20: Maintenance Shop and Equipment Storage Shed, north elevation (left) and west elevation (right), view southeast (LSA 2021)

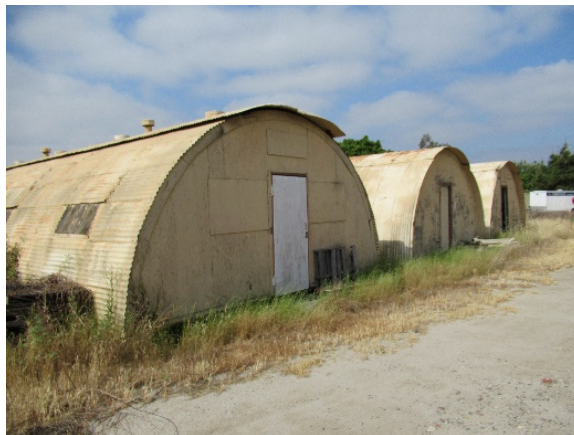
Located on the site's east-central portion are three Quonset Huts laid out east to west; however, only the one at the center and to the east were on site in 1976 (Figure 21). The Huts are clad with painted corrugated metal sheets. Windows have been boarded up. Single wood doors are located on the north and south elevations. The Quonset Huts are in poor condition and retain a moderate degree of integrity.

Figure 21: Quonset Huts, north elevation, view southwest (LSA 2021)

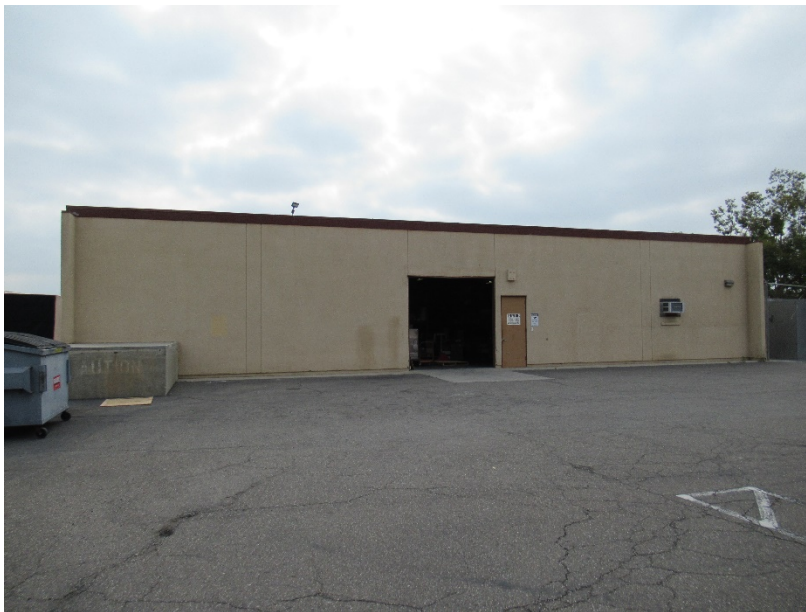
***P3a. Description:** (Describe resource and its major elements. Include design, materials, condition, alterations, size, setting, and boundaries)
Located directly east of the Educational Center is the Warehouse. It has a rectangular floorplan, flat roof with low parapet wall and evenly spaced squared downspouts along the roofline. The building is clad with smooth stucco. A rollup car door is at the west elevation and a single metal door is immediately to its south. A secondary entrance is located on the south elevation. The Warehouse is in good condition and retains a good degree of integrity.

P5b. Description of Photo: (View, date, accession #) West elevation, view east (May 14, 2021)

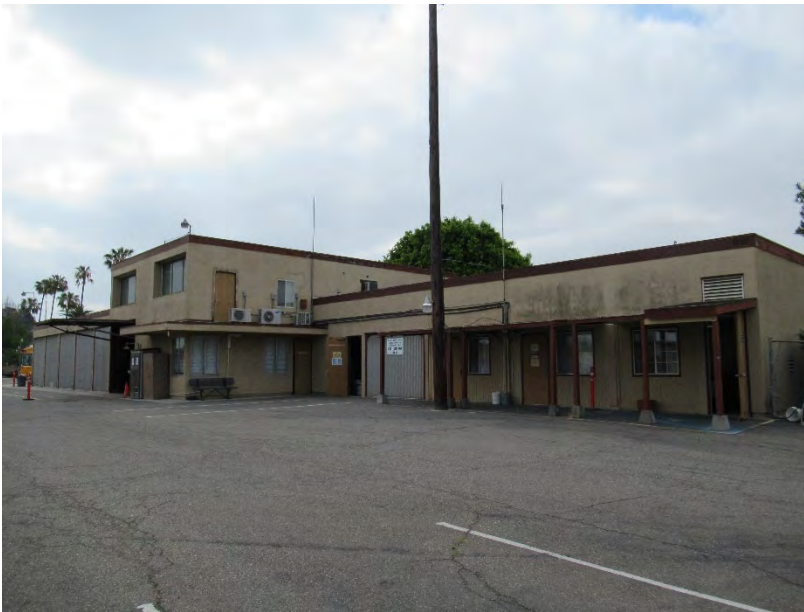
*P3a. Description: (Describe resource and its major elements. Include design, materials, condition, alterations, size, setting, and boundaries) The Vehicle Maintenance Shop is located on the southern edge of the subject parcel. Though nearly rectangular, the building has an irregular floorplan and features a central two-story projection. It is capped with a flat roof and low parapet walls; downspouts are visible only on the south elevation. The building is clad with smooth stucco. The east, west, and south elevations are devoid of any fenestration except for a few vents at the south elevation. The north elevation is lined with five garage door openings east of the central projection. West of the projection are three contemporary vinyl sash sliding windows, four single doors, two of which are located beneath shed roofs that were added later, and a one-car garage door. The central projection features one garage door and one single door entrance on the first floor and another on the second floor. Windows are a combination of metal casement windows and metal sliding windows. The Vehicle Maintenance Shop is in fair condition and retains a moderate degree of integrity.

P5b. Description of Photo: (View, date, accession #) North elevation, view southeast (May 14, 2021)

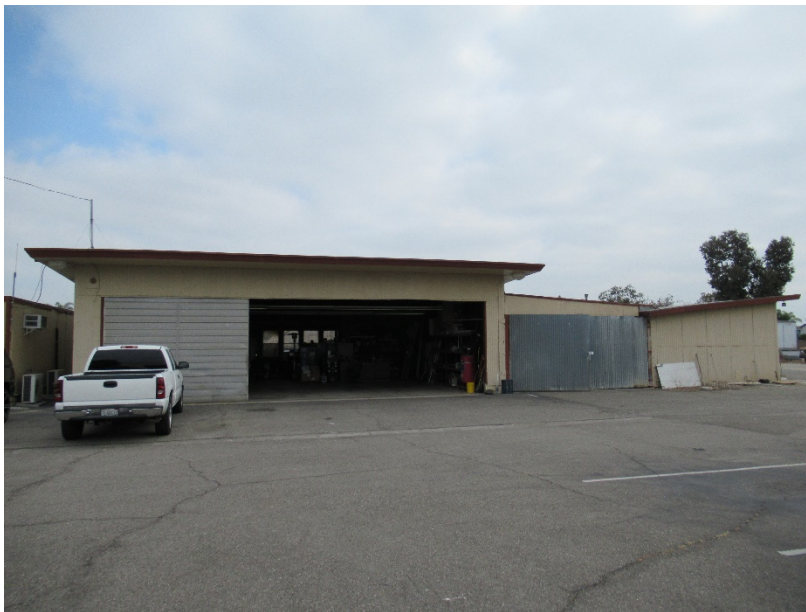
***P3a. Description:** (Describe resource and its major elements. Include design, materials, condition, alterations, size, setting, and boundaries)
The Maintenance Shop and Equipment Storage Shed, which consist of two buildings connected by a rudimentary shed made up of plywood siding and corrugated metal doors, were constructed between 1969 and 1976. The Maintenance Shop, located west of the Equipment Storage Shed, has a rectangular floorplan with a flat roof that slopes to the north with wide overhanging boxed eaves. The building is clad with painted corrugated metal sheets. The north elevation features one large opening that encompasses the majority of the elevation and is closed off by three stackable, sliding, metal doors. Four wood sash double-hung windows are located on the north elevation and west elevation; all are screened with metal security mesh. A single door is located on the north elevation.

The Equipment Storage Shed, located east of the maintenance shop, has a rectangular floorplan, a flat roof that slopes to the west, and open eaves. It is clad with painted corrugated metal sheets. Two car openings, which consist of two wood, barn doors, are located on the east elevation. The Maintenance Shop and Equipment Storage Shed are in fair condition and retain a good degree of integrity.

P5b. Description of Photo: (View, date, accession #) South elevation, view north (May 14, 2021)

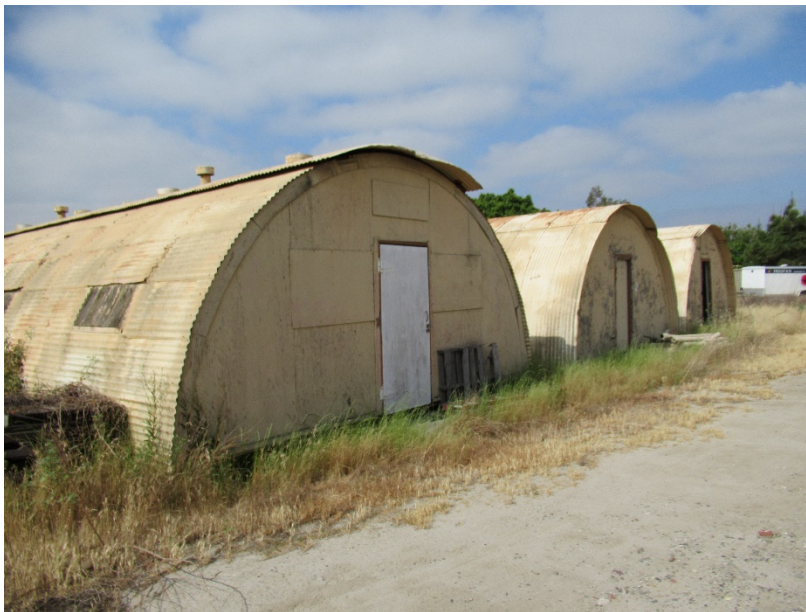
***P3a. Description:** (Describe resource and its major elements. Include design, materials, condition, alterations, size, setting, and boundaries) Located on the site's east-central portion are three Quonset Huts laid out east to west; however, only the one at the center and to the east were on site in 1976. The Huts are clad with painted corrugated metal sheets. Windows have been boarded up. Single wood doors are located on the north and south elevations. The Quonset Huts are in poor condition and retain a moderate degree of integrity.

P5b. Description of Photo: (View, date, accession #) North elevation, view southwest (May 14, 2021)
